# Your Inspection Report

No Fixed Address  
Ottawa, ON K1J 7W3

**INSPECTION DATE:**  
Tuesday, May 7, 2013

Report No. 1034, v.2

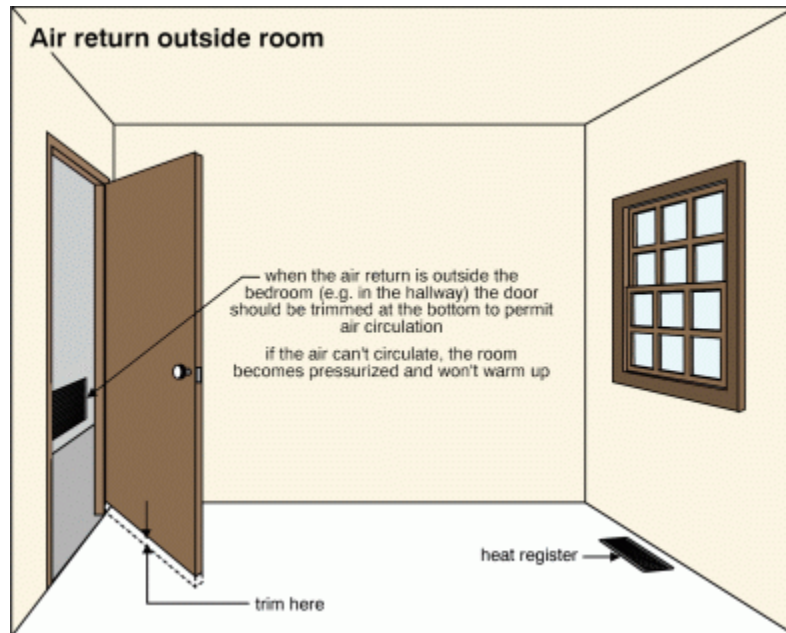
5. Condition: • [Poor location](#)

Cold air return for two of the bedrooms is fed from the hallway. To ensure balanced heating when doors are closed, an air gap should be provided at bottom of each door.

Location: West Second Floor Bedrooms

**Task:** Improve

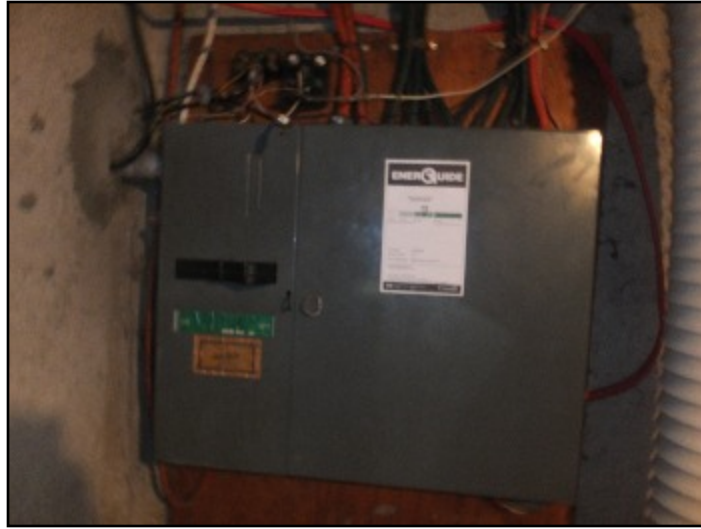
4. Old

**6. Condition:** • [Old](#)

AC appears old although this cannot be confirmed. As such, risk of failure is likely to be high. Plans for replacement should be Budgeted accordingly

**Location:** Left Exterior

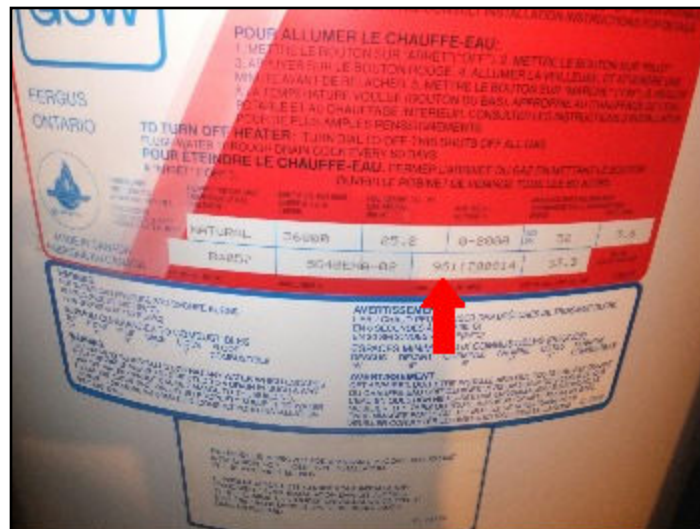
5. 18 years

8. Condition: • [Near end of life expectancy](#)

Location: Basement Utility Room

Task: Replace

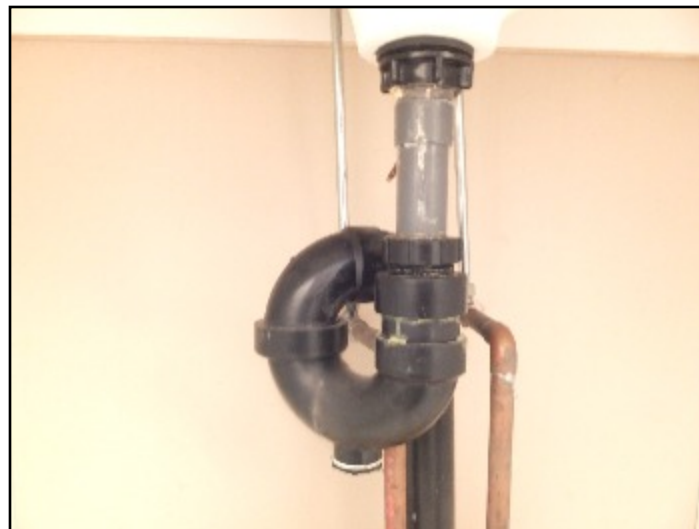
6. *Wrong type*

9. Condition: • [Wrong type](#)

Implication(s): Sewer gases entering the house

Location: Basement Powder room sink

Task: Repair

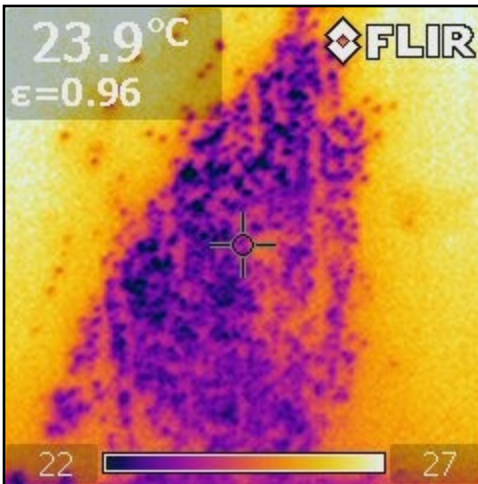
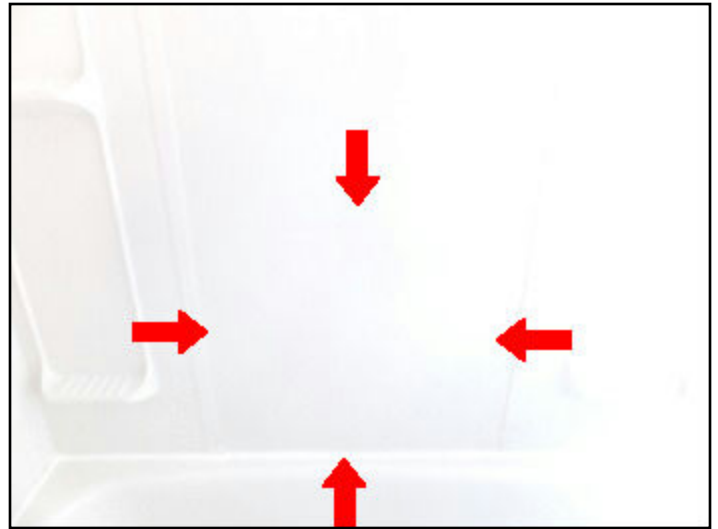
12. Condition: • [Leak](#)

Moisture was detected using thermal imaging in the lower area of the centre rear panel of the tub enclosure. This was confirmed using a moisture meter.

Location: Second Floor Bathroom

7. Identified moisture are in blue

8. Identified moisture area

Task: Repair

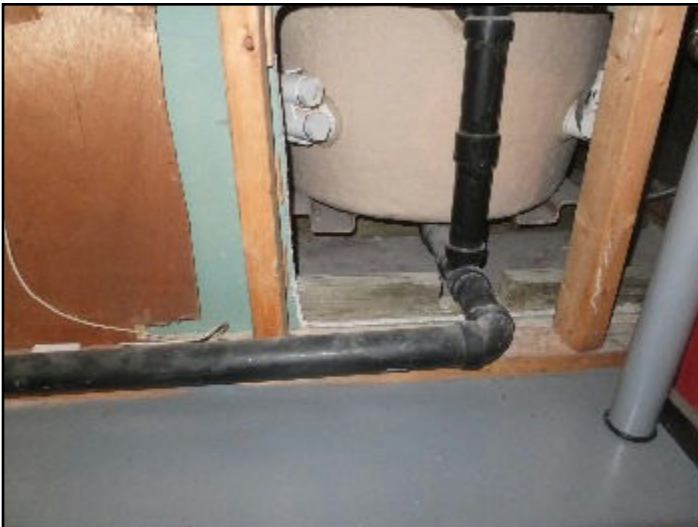
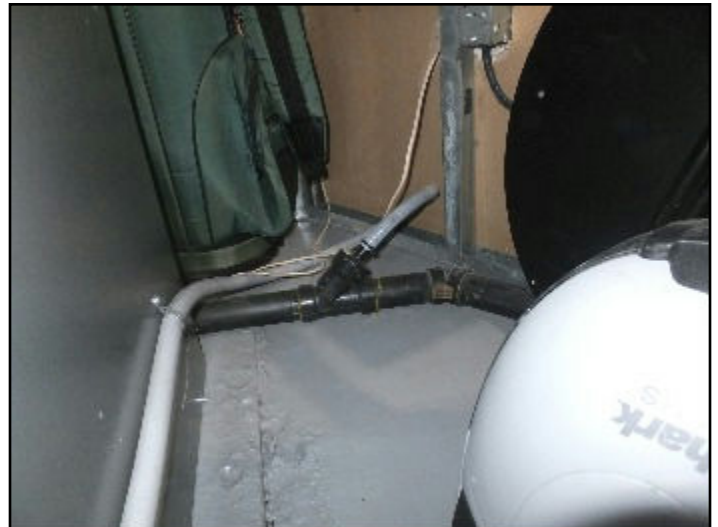
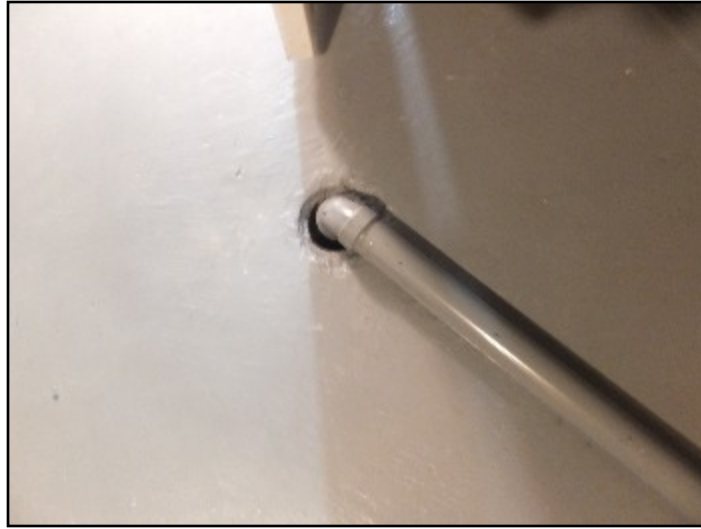
**13. Condition:** • Jucuzzi drain line inadequate. Drain line from Jucuzzi runs across surface of basement floor to floor drain. This is considered a makeshift solution that needs to be corrected with consideration given to ensure appropriate venting. Further evaluation by a licensed plumber is recommended to assess options.

**Implication(s):** Potential flooding of basement, trip hazard

9. Drain line at Jucuzzi

10. Drain line traverses floor area

11. Termination at floor drain

**Task:** Repair

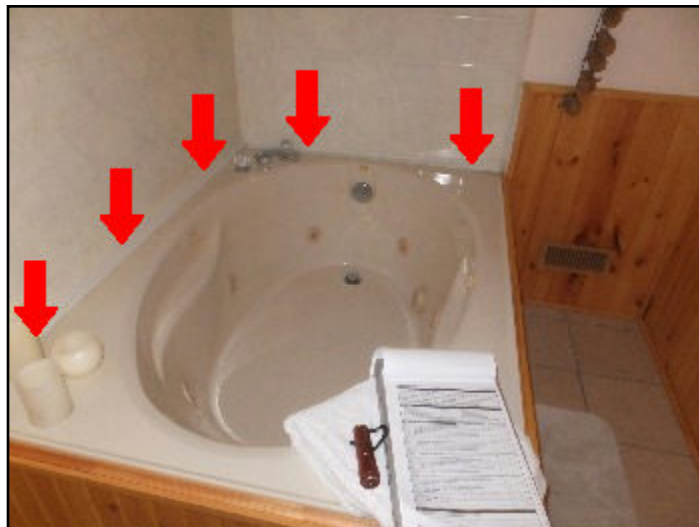
12.

**15. Condition:** • Plastic flange at base of wall around tub is inadequate

**Location:** Basement Jacuzzi

**Task:** Repair

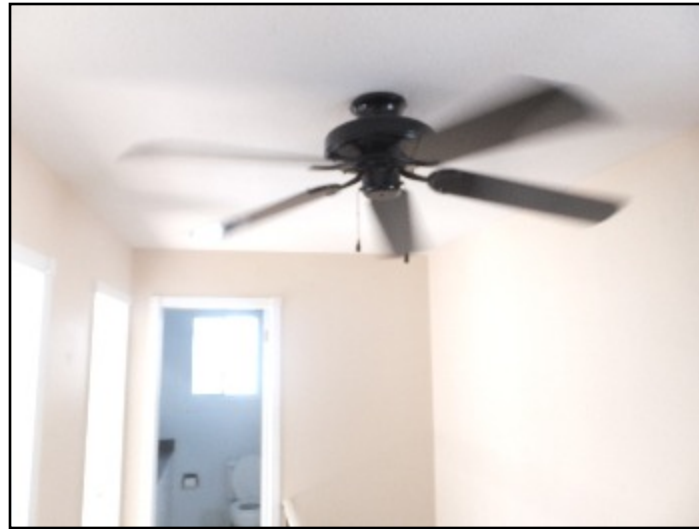
#### 18. Condition: • [Missing](#)

Fan needs to be upgraded/replaced with lighting capability

**Location:** Second Floor Staircase

13. Missing

**Task:** Provide

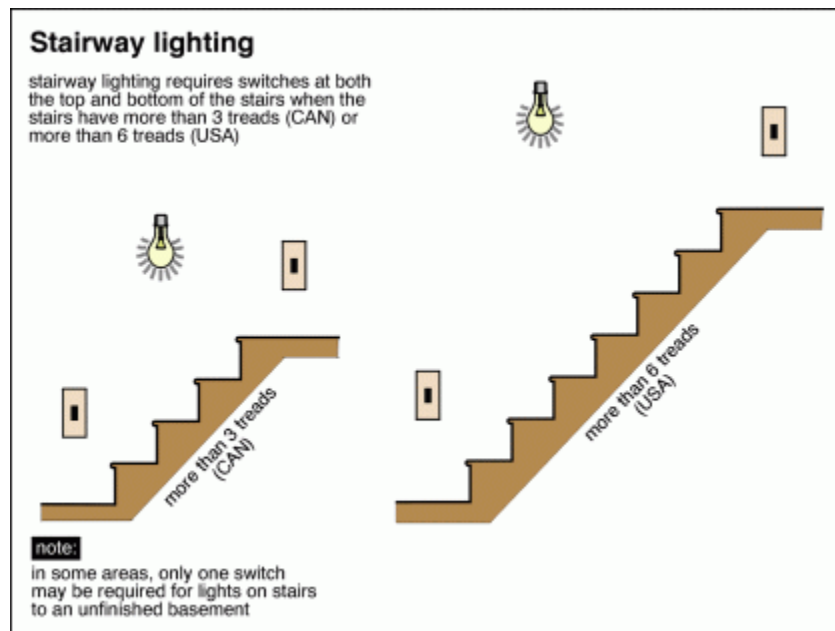
19. Condition: • [Not controlled by three way switch](#)

Location: Basement Staircase

Task: Provide
