# Your Inspection Report

No Fixed Address  
Ottawa, ON K1J 7W3

**INSPECTION DATE:**  
Tuesday, May 7, 2013

Report No. 1034, v.2

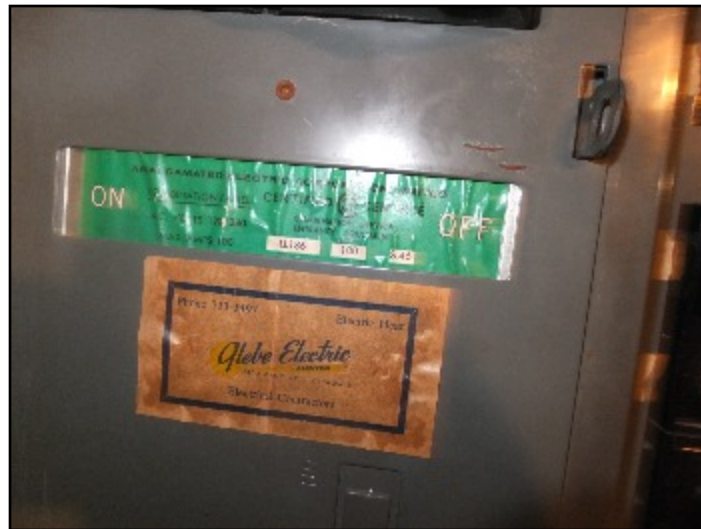
1. 100 Amps

• [100 Amps](#)

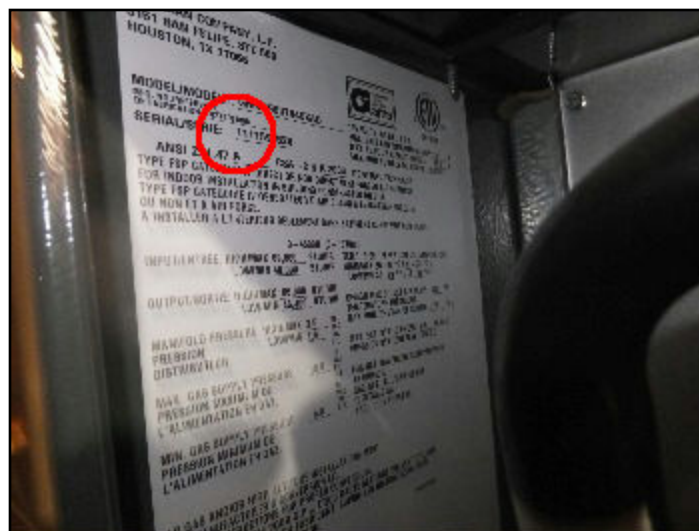
2. Furnace

• [2 years](#)

Typical life expectancy: • Furnace (high efficiency) 15 to 20 years

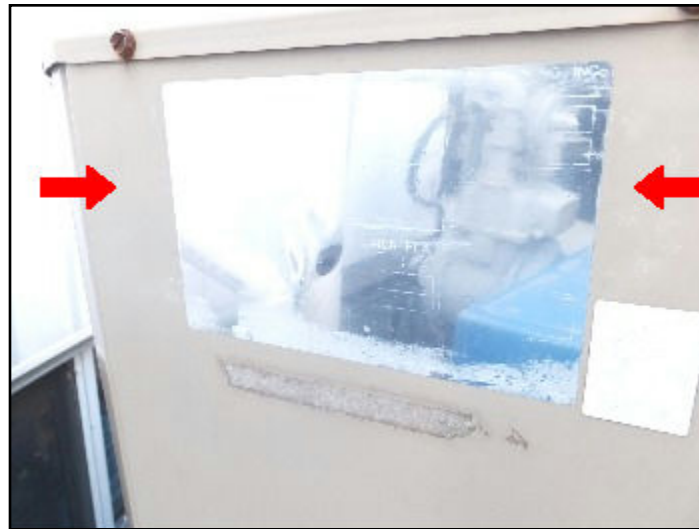
3. Not legible

• Not legible

AC appears old although this cannot be confirmed. As such, risk of failure is likely to be high. Plans for replacement should be Budgeted accordingly

**Implication(s):** Equipment failure | Reduced comfort
